# SungSan Bridge- General Characteristics

Aim	To monitor the damage & fatigue stress at the gerber sections
Location	Seoul, Korea
System integrator	GMG (Geotechnical Monitoring Group) http://www.gmgnow.com
System supply & technical support	KAISEN (Korea Advanced & Innovative Sensing Technology), Inc. http://www.kaisen.co.kr
Customer	Seoul City
Date	2009
Instrumentation	(1) Micron Optics sm130
Sensors	(36) Micron Optics os3100 Spot-Weld Strain Gage (13) Micron Optics os4100 Temperature Comp. Sensors
Project Scope	<ul> <li>Long-term monitoring of strain at 14 different locations.</li> <li>On-site and remote data retrieval.</li> </ul>

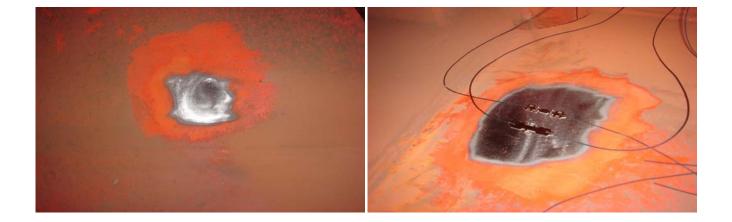
Sensor installation : spot welding

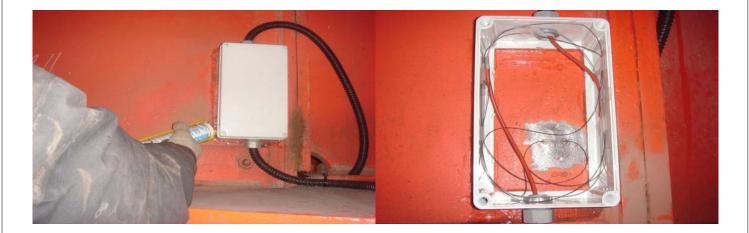
Productive box installation

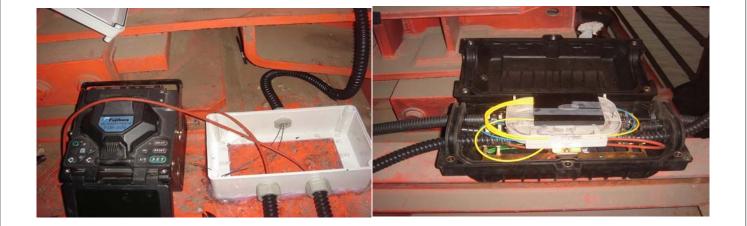
### Splicing
